TS-PIC-90953
January 1991

EPA **Site Analysis**
Albion-Sheridan Township Landfill
Albion, Michigan

Site Analysis
Albion-Sheridan Township Landfill
Albion, Michigan

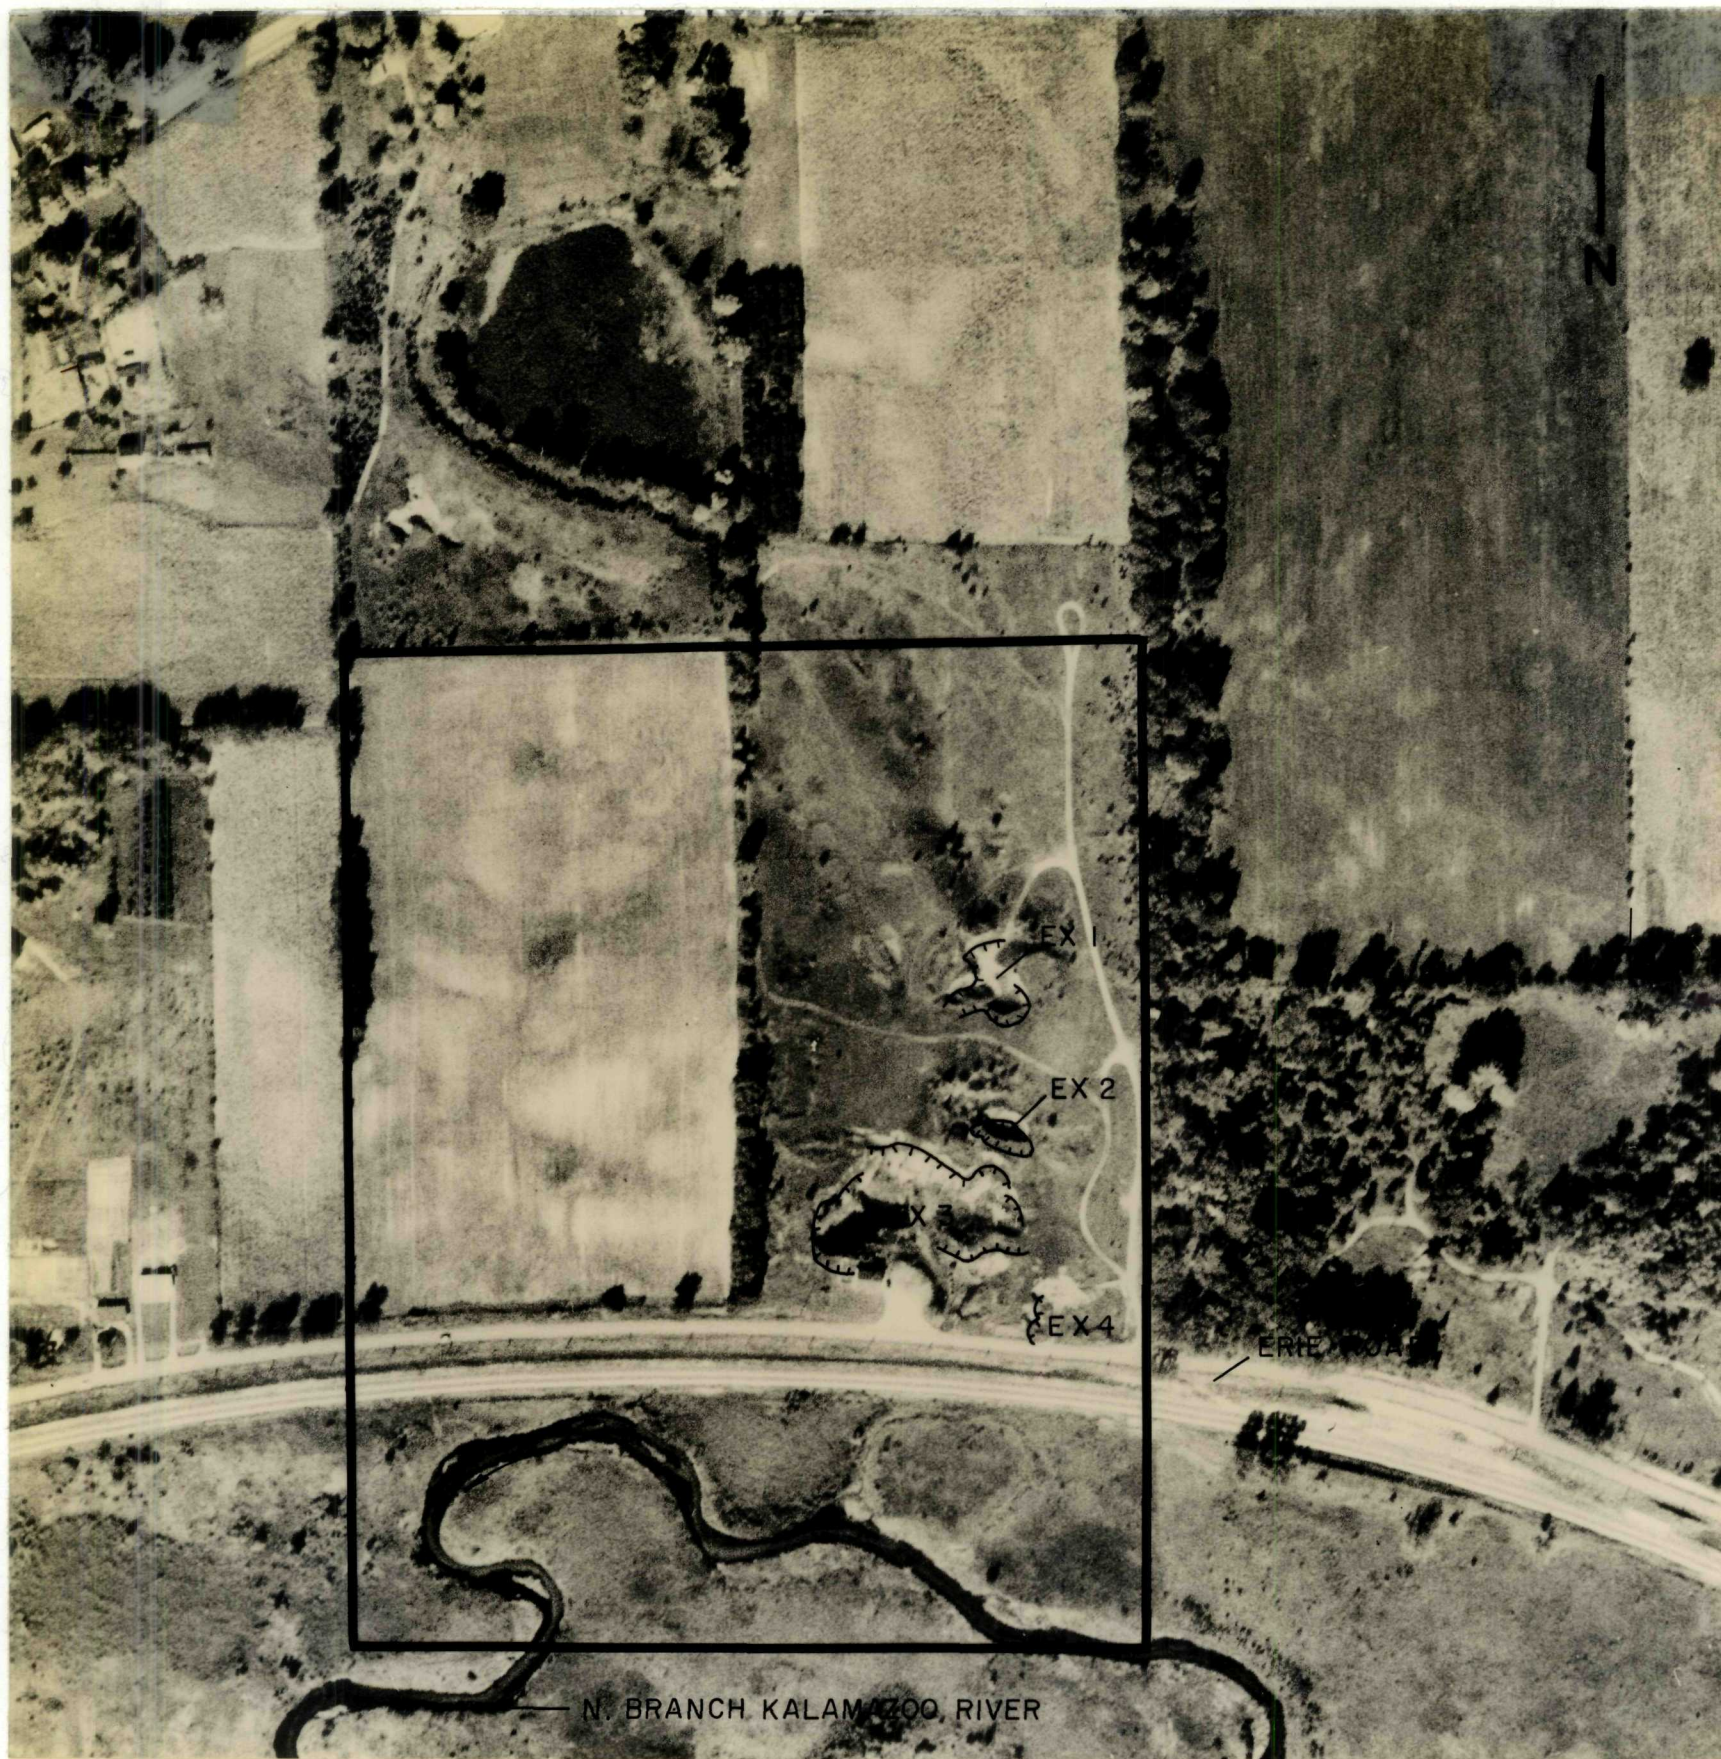
FIGURE 2
ALBION-SHERIDAN LF

Figure 2 represents the site prior to landfilling activity. The eastern half of the site includes several excavation areas (EX1-EX4). EX3 contains liquid (not annotated). Access roads are also visible onsite. The western portion of the site is undisturbed. The southern portion of the site includes a section of Erie Road, a rail line (not annotated), and the North Branch of the Kalamazoo River.

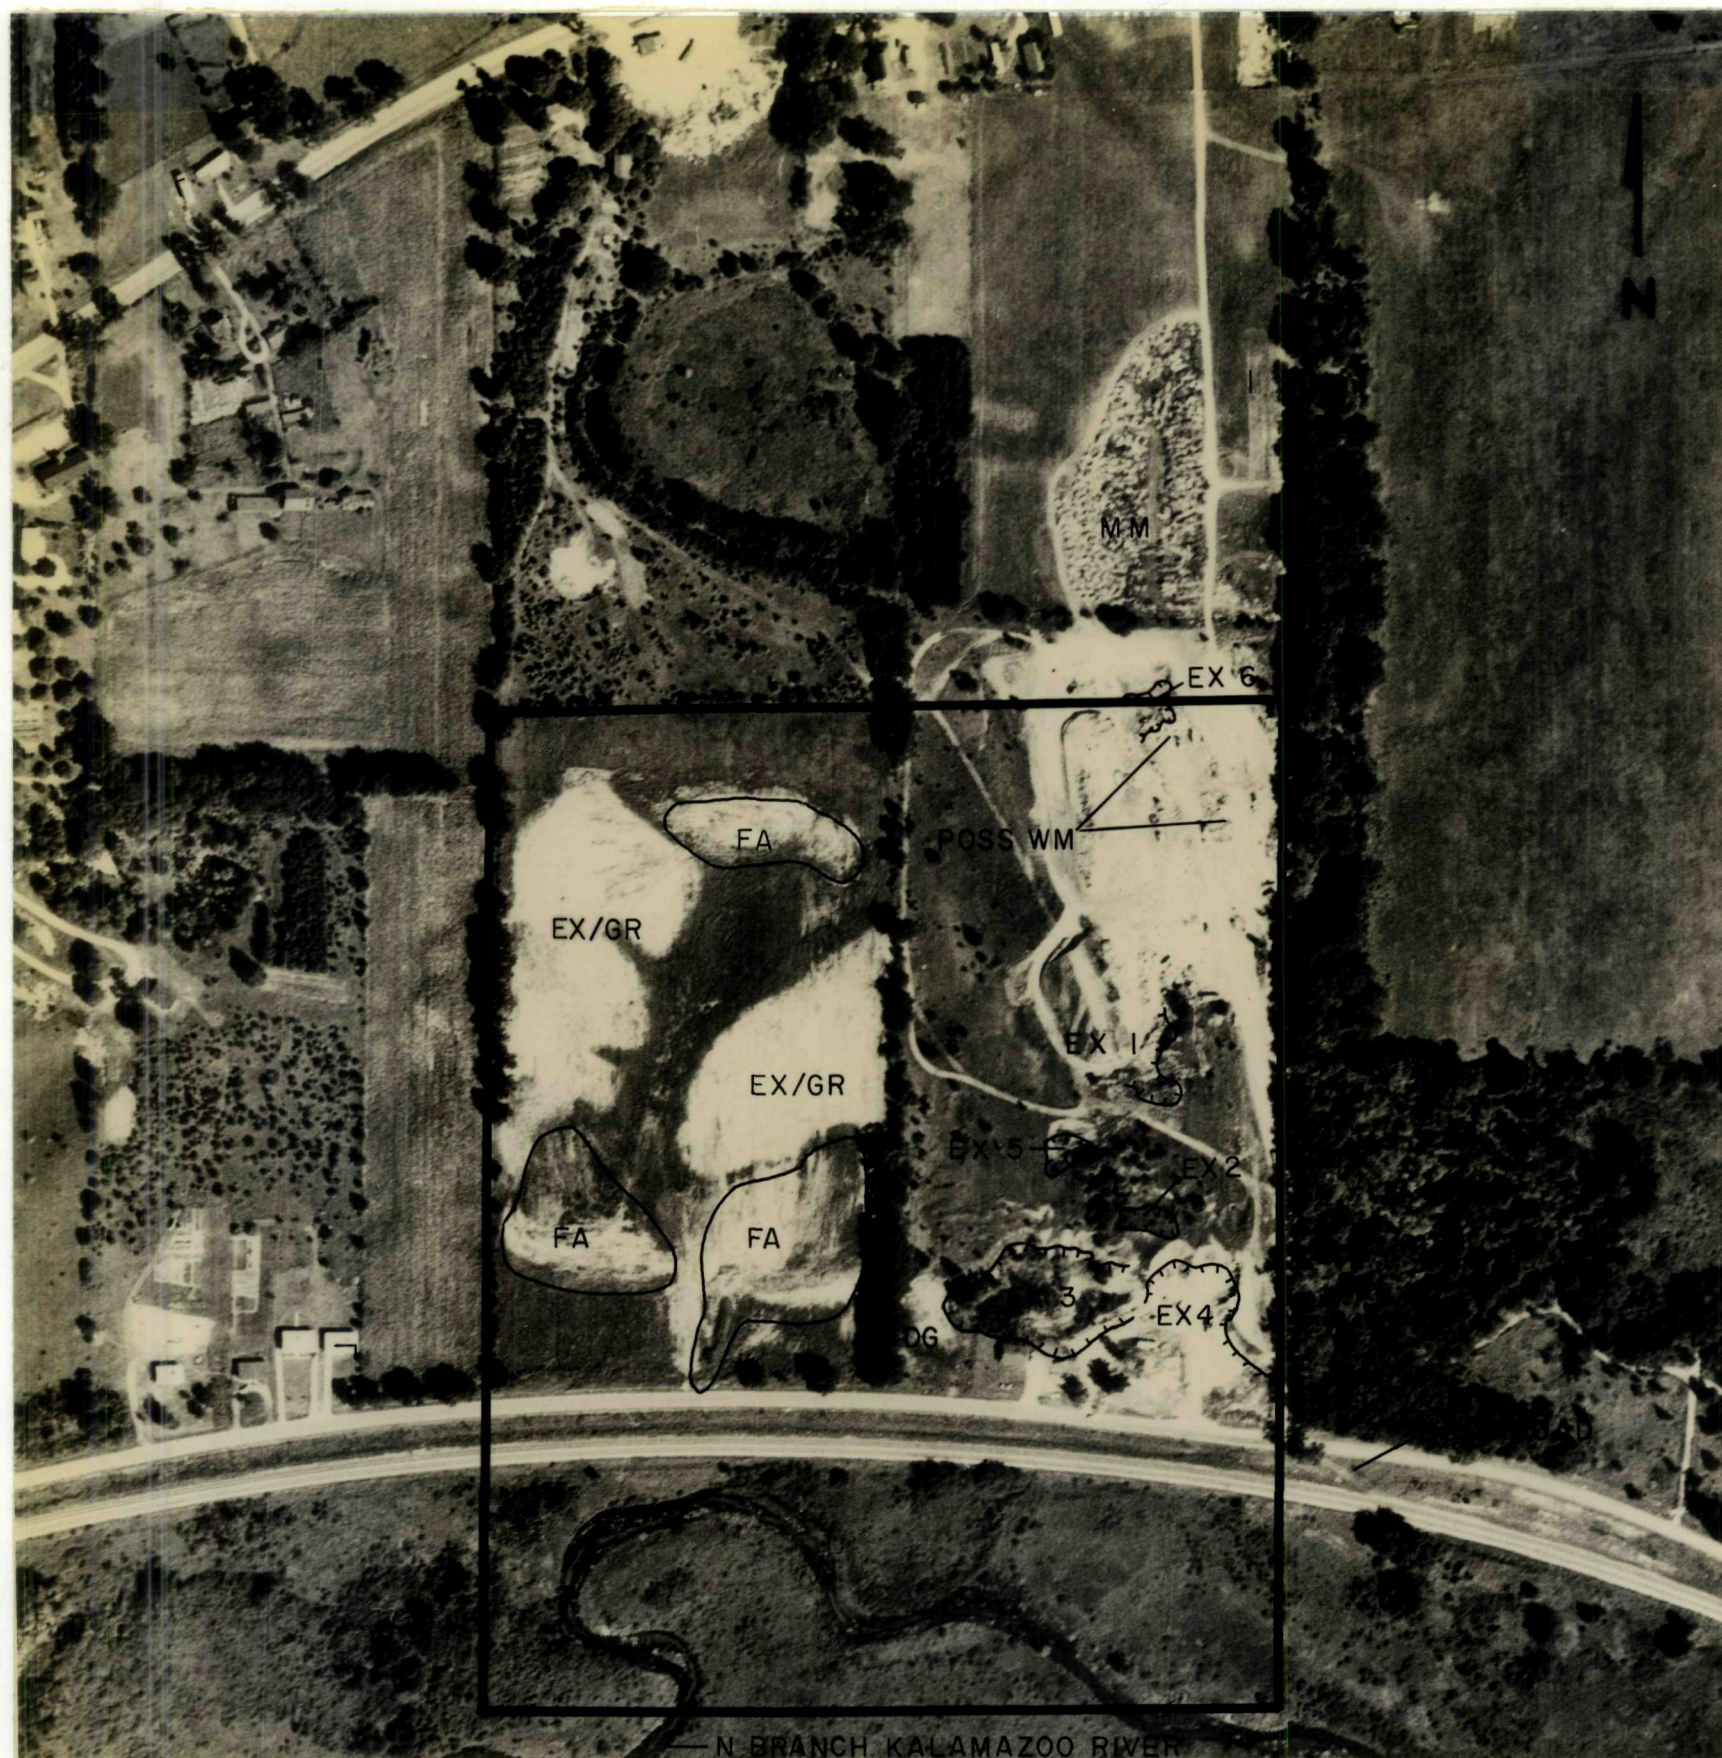
FIGURE 3
ALBION-SHERIDAN LF

Excavation activity has increased considerably in the northeastern portion of the site. EX1 has expanded. EX2 has revegetated and no significant change in size or shape is visible. EX3 continues to contain liquid and to occupy much the same area. Disturbed ground (DG) is visible west of EX3. EX4 has also increased in size, and now includes the area east of EX3 to the eastern site boundary. Another excavation, EX5, is now present south of EX1. EX6 is located on the northern site boundary, and possible waste material (WM) is visible to the south.

Three areas of fill (FA) are in the western portion of the site where fields were visible in 1961. The area has also been excavated and graded (GR).

Variably toned mounded material (MM), possibly waste material, is present north of the site boundary.

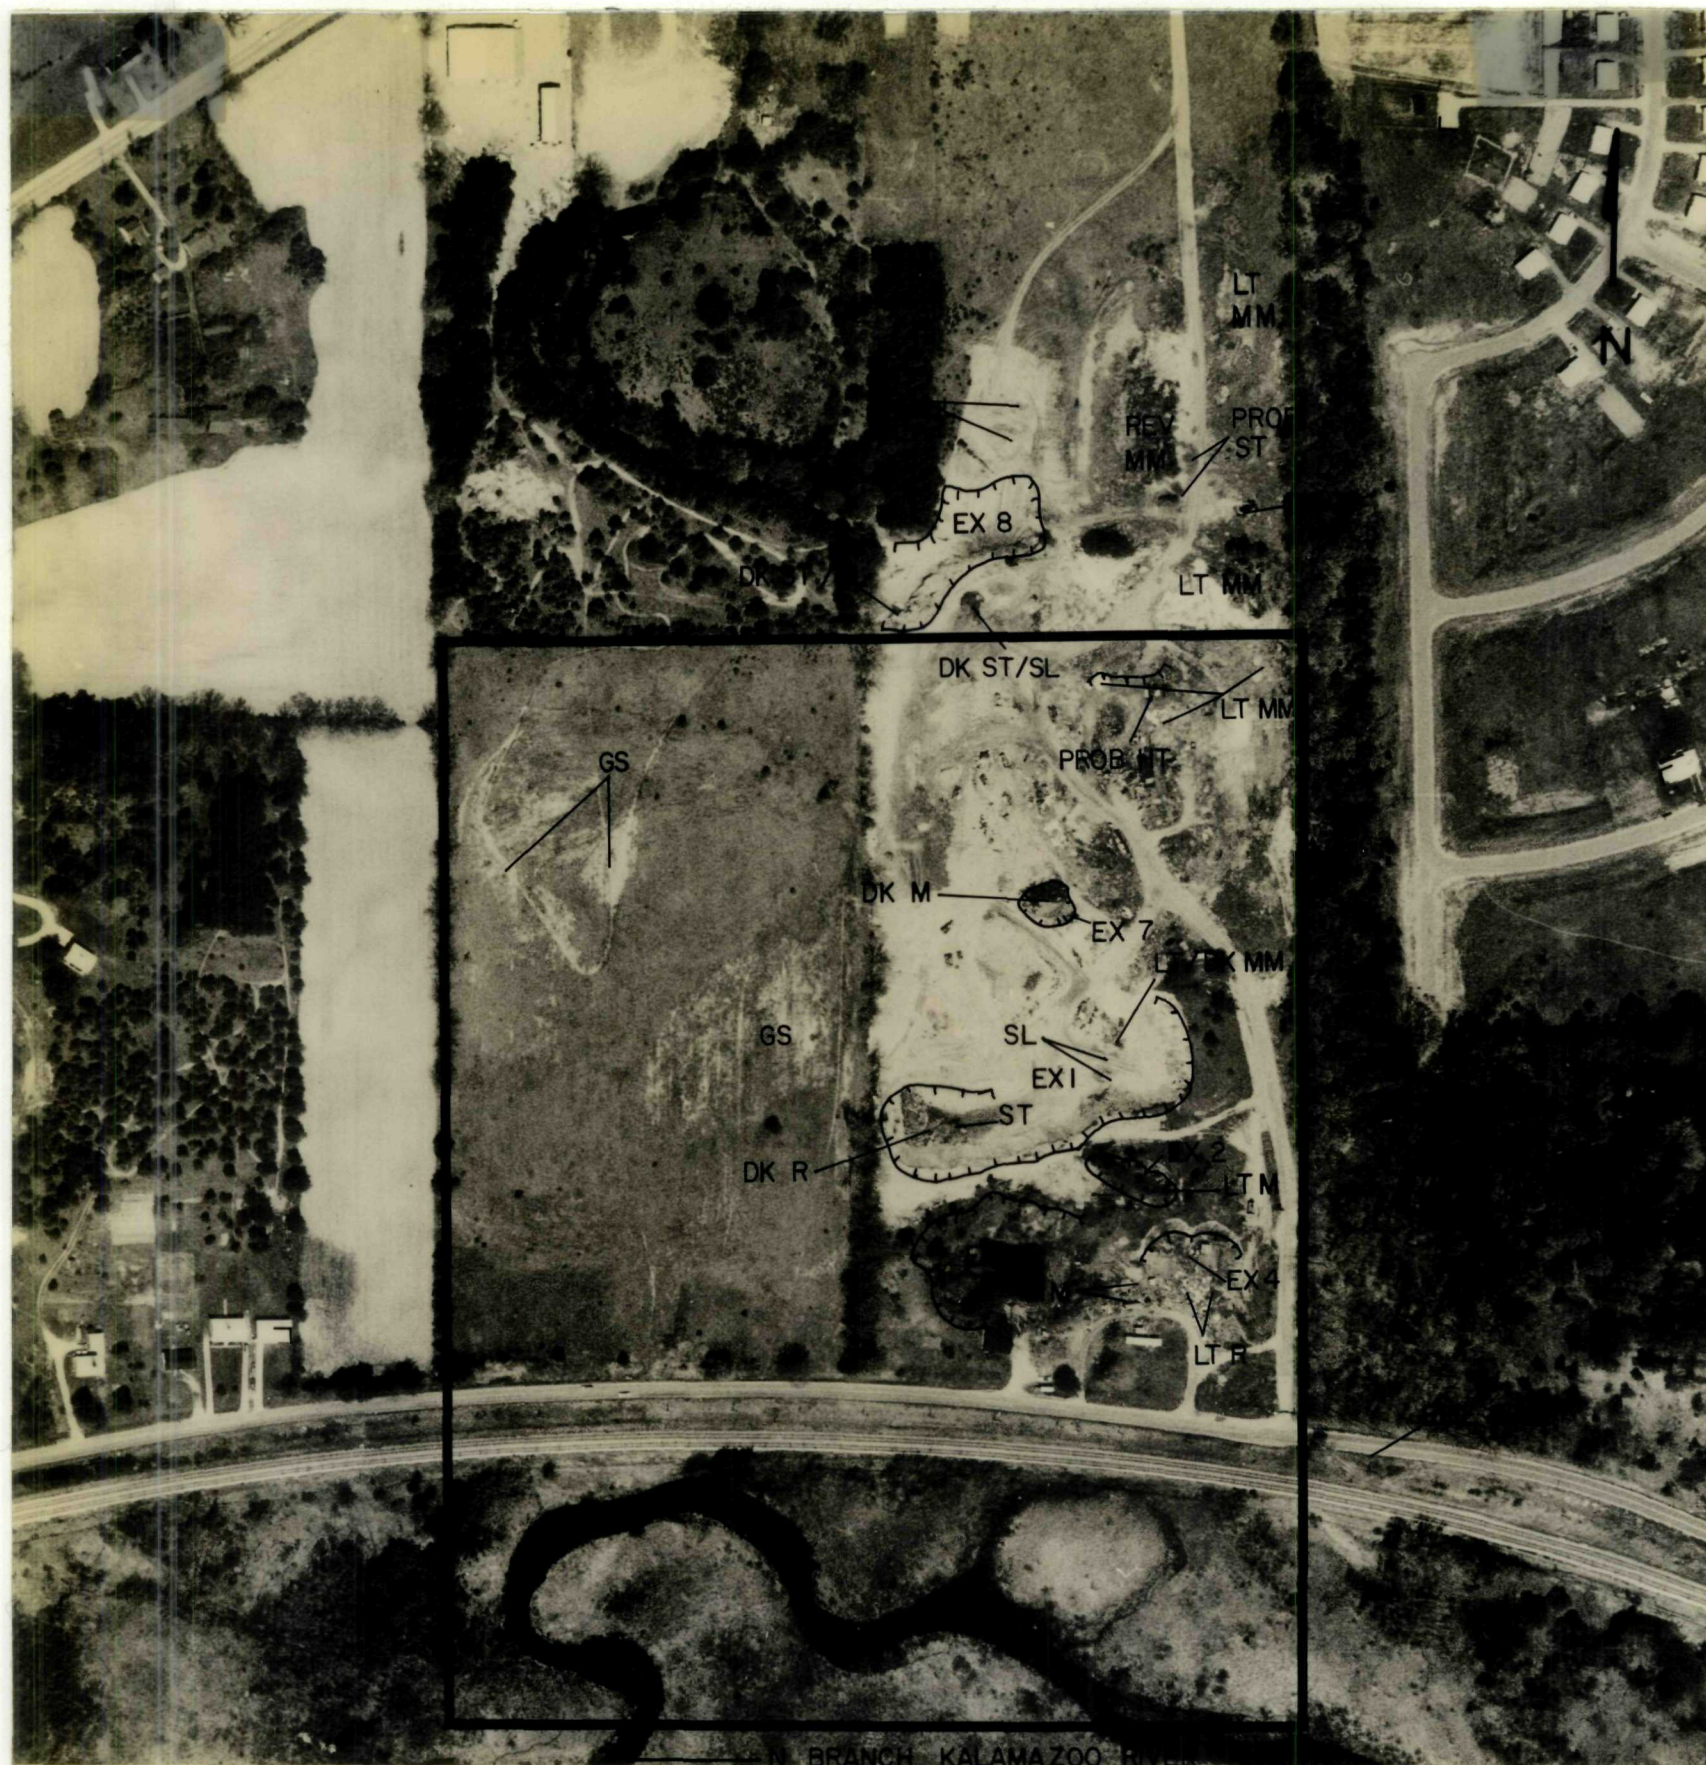
FIGURE 4
ALBION-SHERIDAN LF

The site continues to be active. Landfilling activities are now visible. The northeastern portion of the site has been extensively excavated and landfilled. Scattered refuse, vehicles, and equipment (none annotated) are present throughout this area. The area of EX1 has increased and occupies a large portion of the eastern portion of the site. The western portion of EX1 contains dark-toned (DK), coarse refuse (R) and a stain (ST). The eastern portion contains two areas of standing liquid (SL) and light- (LT) and dark-toned mounded material. EX2 appears to contain a small amount of light-toned material (M). EX3 continues to contain liquid (not annotated); it does not appear to be an active location of removal or disposal. Mounded material, probably earthen, is present east of EX3. The disturbed ground visible west of EX3 in 1967 has revegetated. EX4 occupies much the same area as in 1967; however, filling has leveled a portion of the eastern slope. Light-toned coarse refuse is visible south of EX4. EX5 is no longer present; it was in the current location of the expanded EX1. EX6 is no longer present; the area has been filled and the present slope has been annotated. Three areas of light-toned material and a probable horizontal tank are in the northeastern portion of the site. EX7 is north of EX1 and contains dark-toned material.

The western portion of the site that was filled and graded in 1967 has revegetated except for two ground scarred (GS) areas; vehicle tracks (not annotated) are also visible in this area.

The site has continued to expand northward since 1967. The mounded material seen north of the site boundary has revegetated (REV). Two probable stains and dark-toned material are in the vicinity of the revegetated mounded material. An excavation, EX8, with two adjacent dark-toned stains or standing liquid, is noted north of the site. Mounded material, probably earthen, is visible north of EX8. Two areas of light-toned mounded material are also visible outside the northern site boundary.

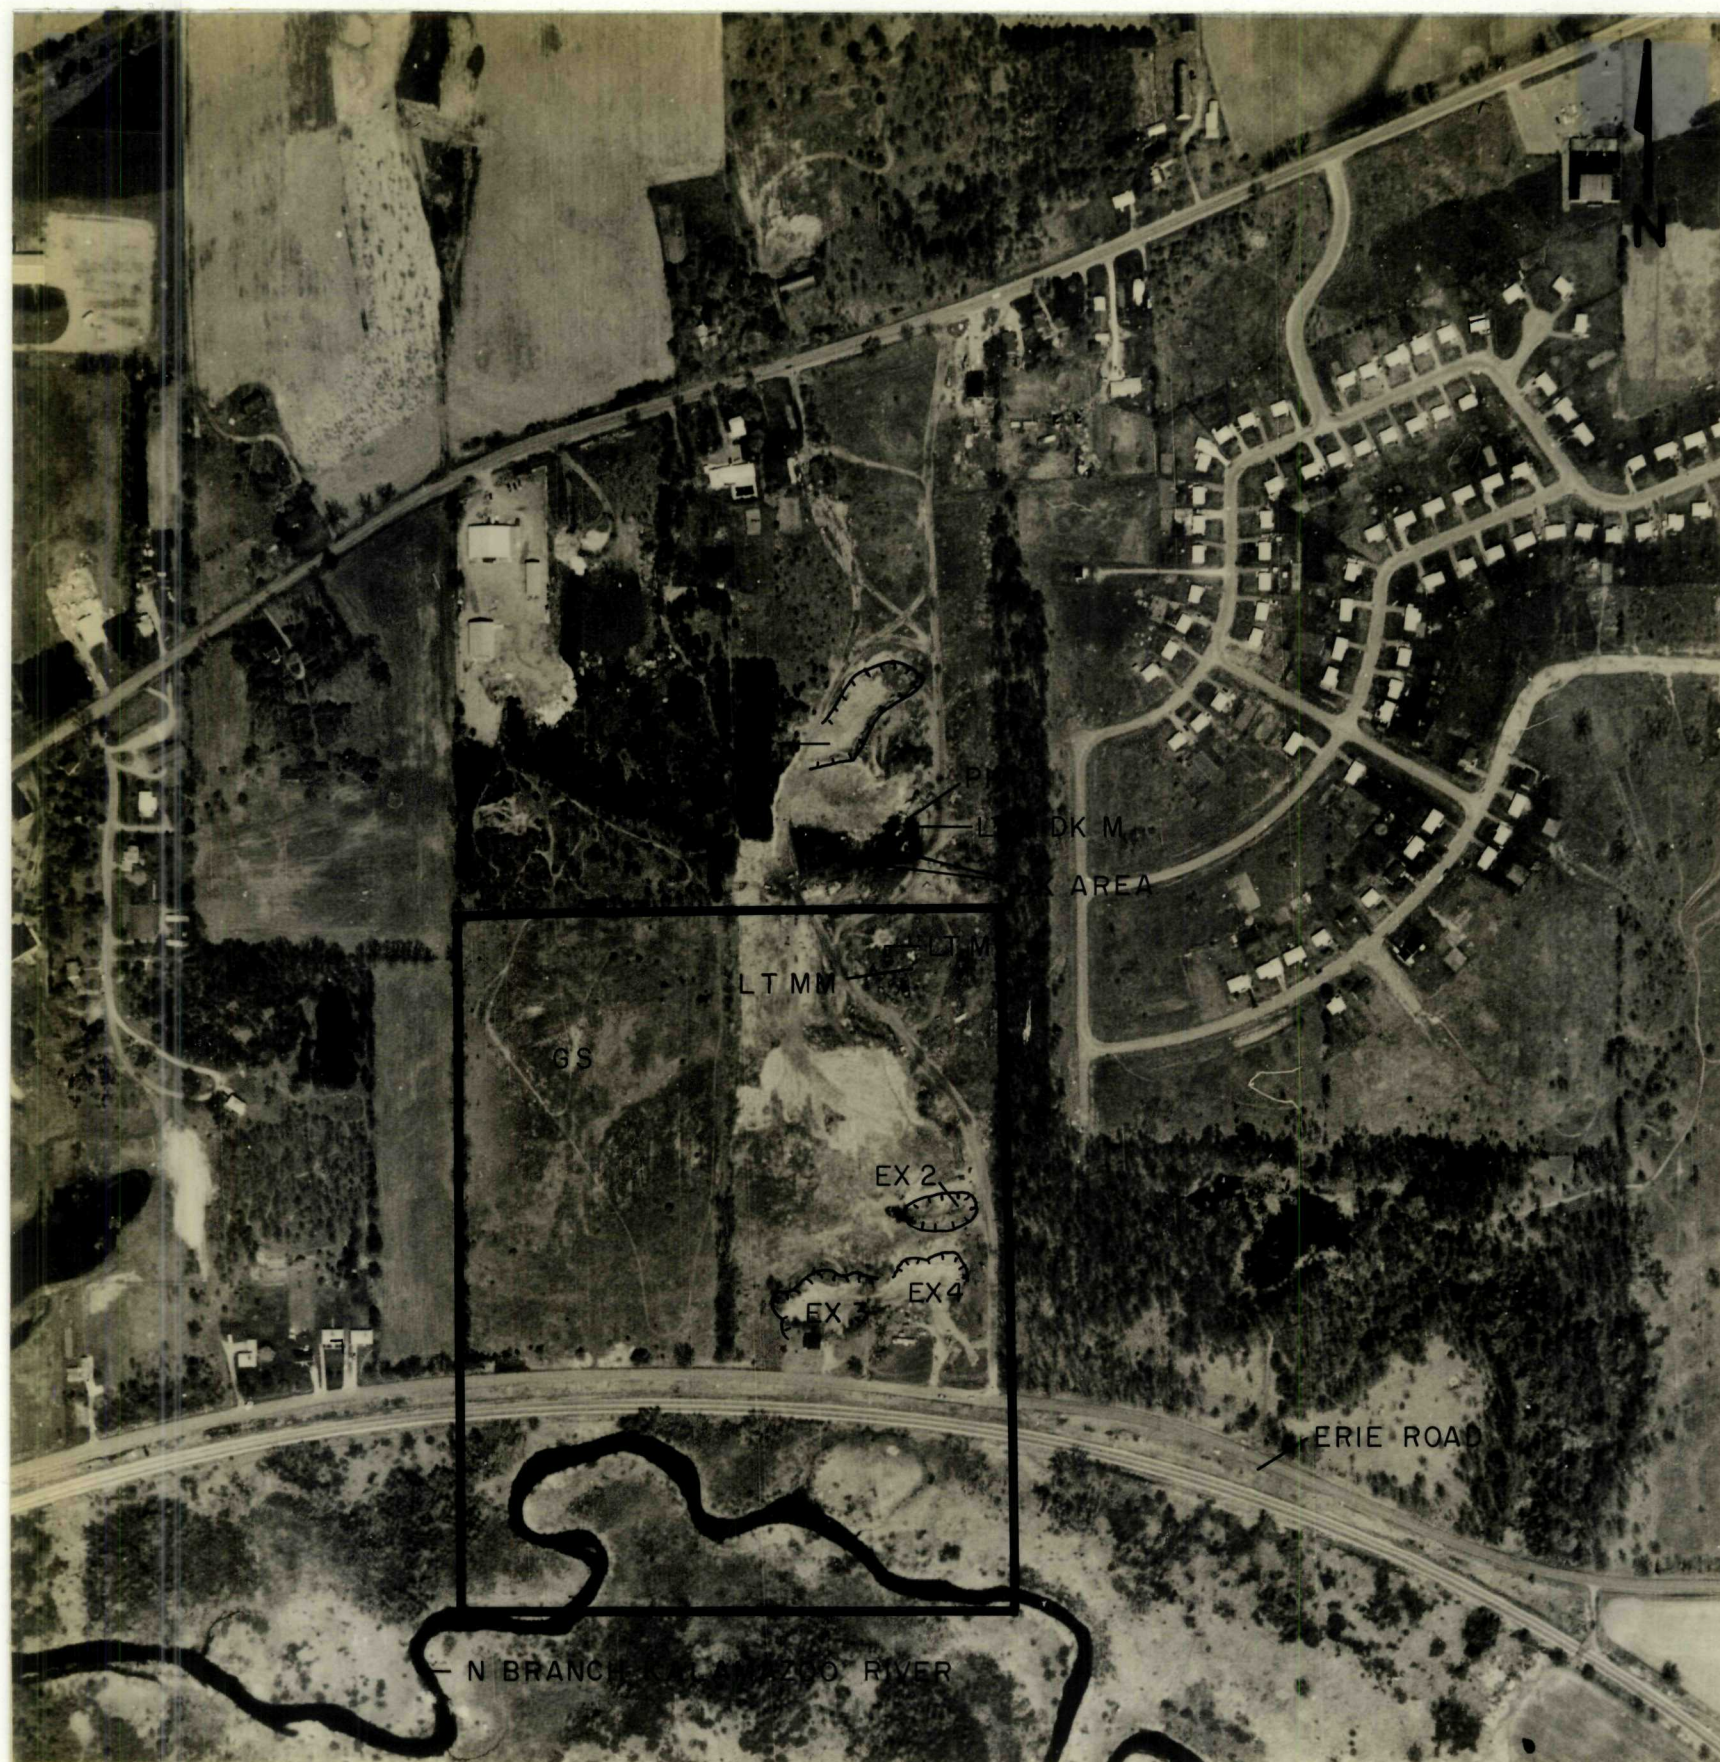
FIGURE 5
ALBION-SHERIDAN LF

Extensive filling activity has occurred in the eastern portion of the site. EX1 and the western portion of EX2 have been filled. EX3 has undergone filling activity and no longer contains liquid. The mounded material visible east of EX3 in 1976 is no longer present. EX4 remains with no significant change. EX7 has been filled. Light-toned material and light-toned mounded material are seen within the northern site boundary.

Ground scarring and vehicle tracks (not annotated) remain visible in the western portion of the site.

The area north of the site boundary continues to be active. EX8 has been filled. An additional excavation, EX9, is seen northeast of the previous location of EX8, in an area where mounded material was visible in 1976. A pit containing light-toned and dark-toned material is located in an area where revegetated mounded material was visible in 1976. A large dark-toned area is present just north of the site boundary.

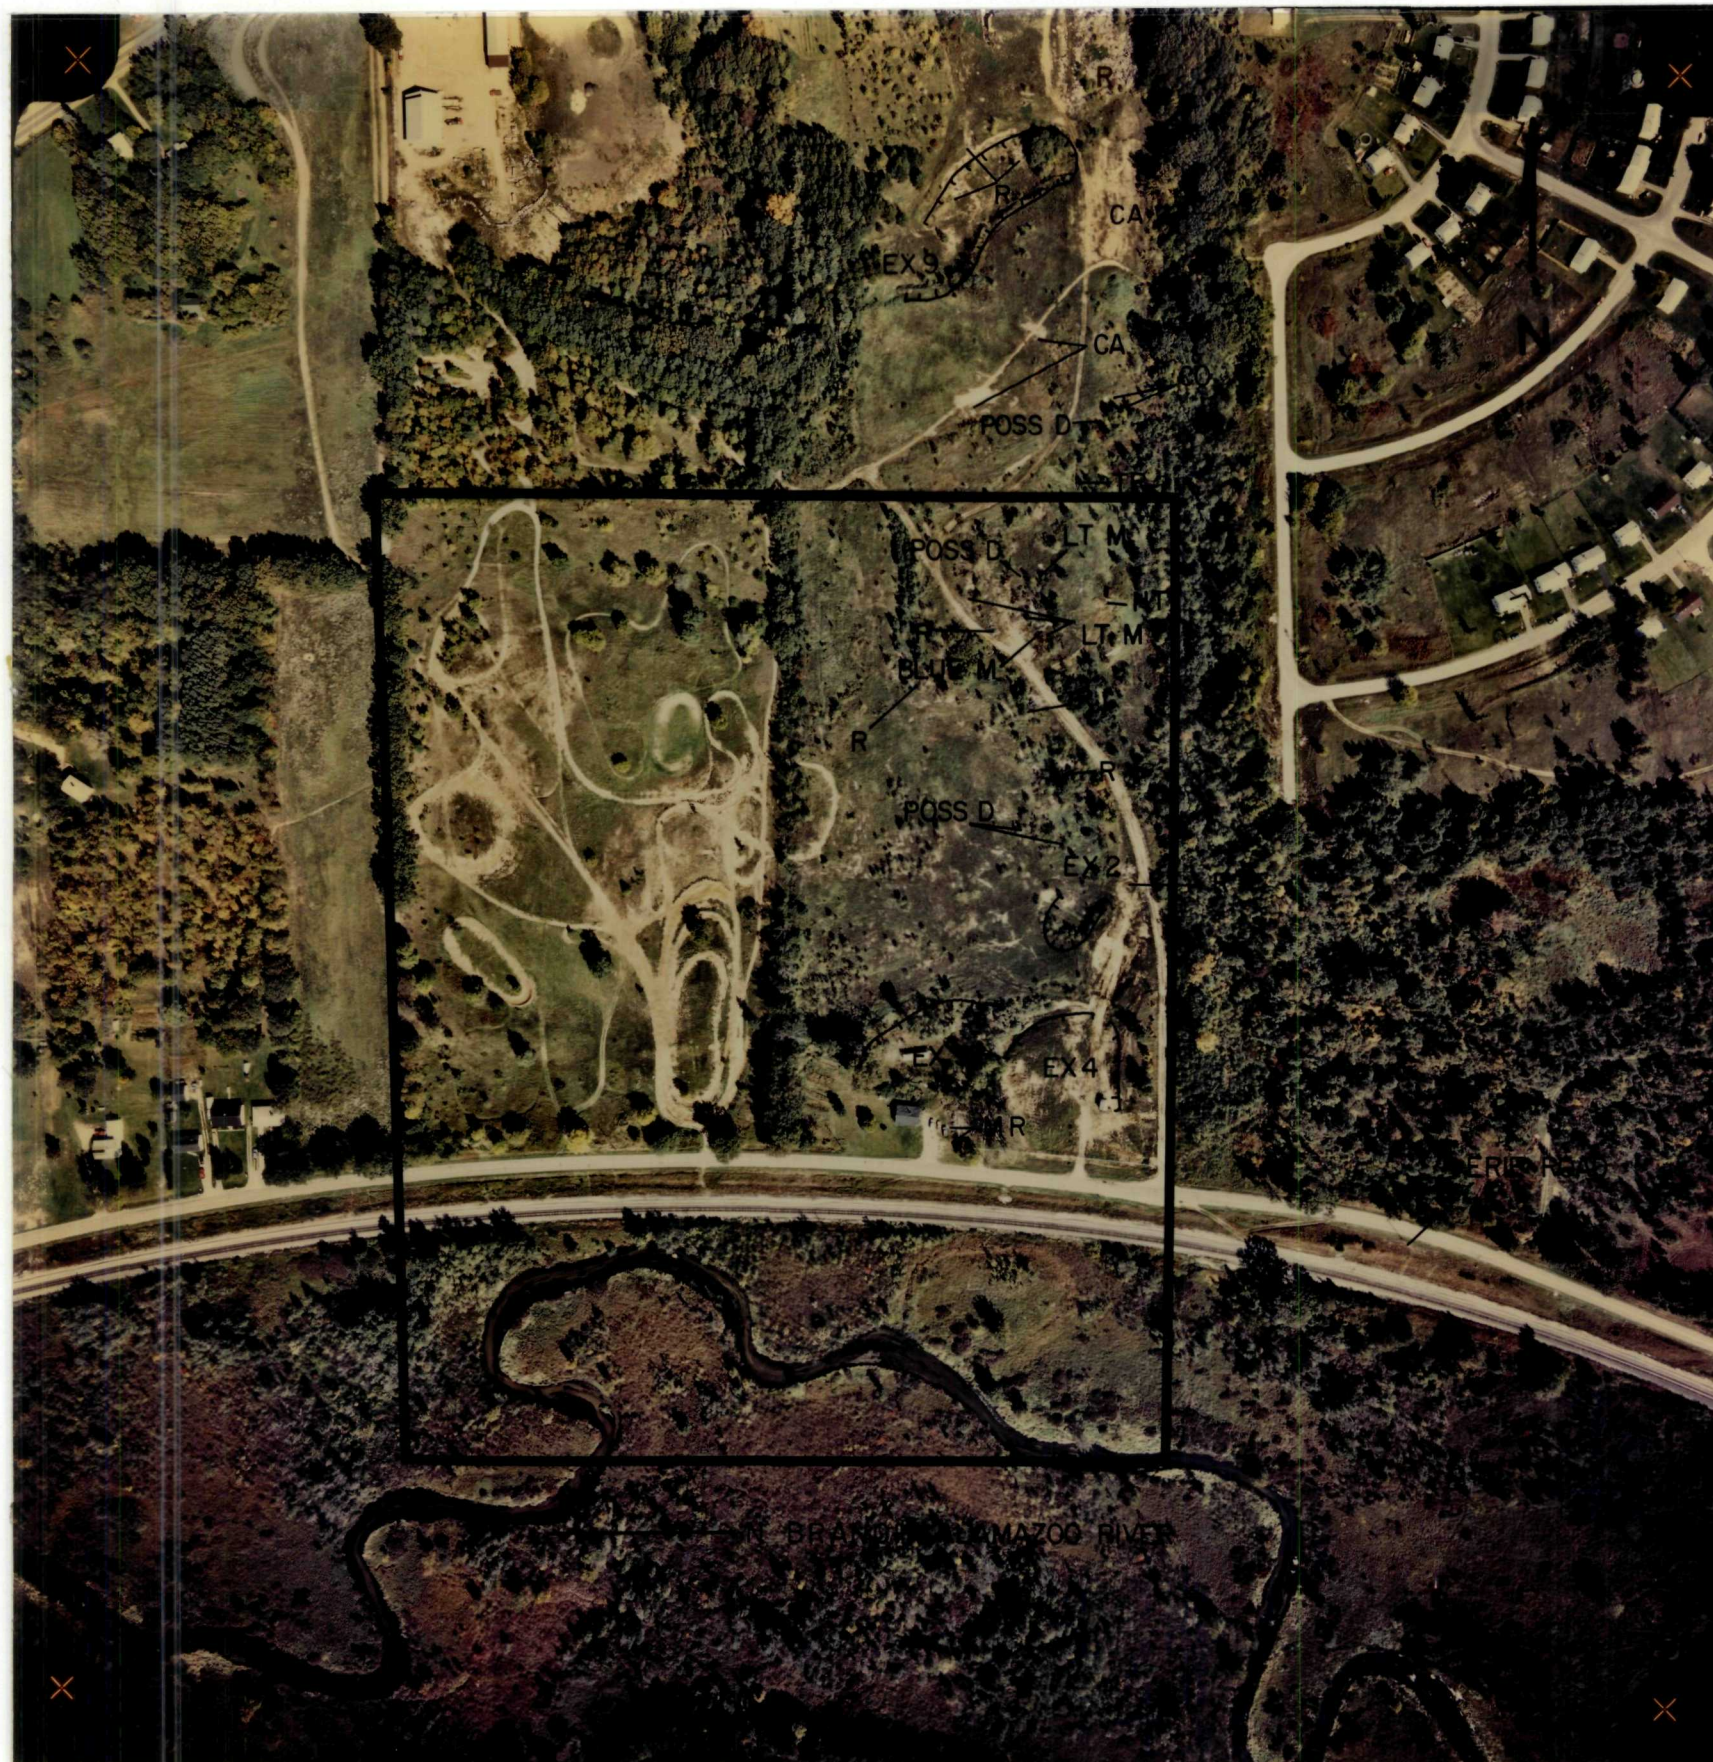
FIGURE 6
ALBION-SHERIDAN LF

The eastern portion of the site has almost completely revegetated, with refuse visible throughout. EX2 has been partially filled, and refuse is visible to the northeast. EX3 remains with no significant change in size or shape, and a trailer (not annotated) is located on top of the filled area. Mounded refuse (MR) is located south of EX3. EX4 remains with no significant change. Within the northeast corner of the site, four areas of light-toned material, an area of blue-toned material, four areas of refuse, three possible drums (D), and a horizontal tank (HT) are visible.

The western portion of the site remains scarred, and extensive vehicle tracks are visible, probably from recreational activity.

The area north of the site boundary remains active. EX9 is actively receiving refuse similar in appearance to the large quantities of refuse to the northeast. The area north of the site contains two cylindrical objects (CO), three cleared areas (CA), a possible drum and a trench (TR). The pit has been filled, and a cleared area is visible in its approximate location. The dark-toned area has revegetated.
